Nassau County Stormwater Management Program

FRANCIS POND SUBWATERSHED STORMWATER RUNOFF IMPACT ANALYSIS AND CANDIDATE SITE ASSESSMENT REPORT

FINAL – October 1, 2007

CASHIN ASSOCIATES, P.C.
Engineering • Planning • Construction Management

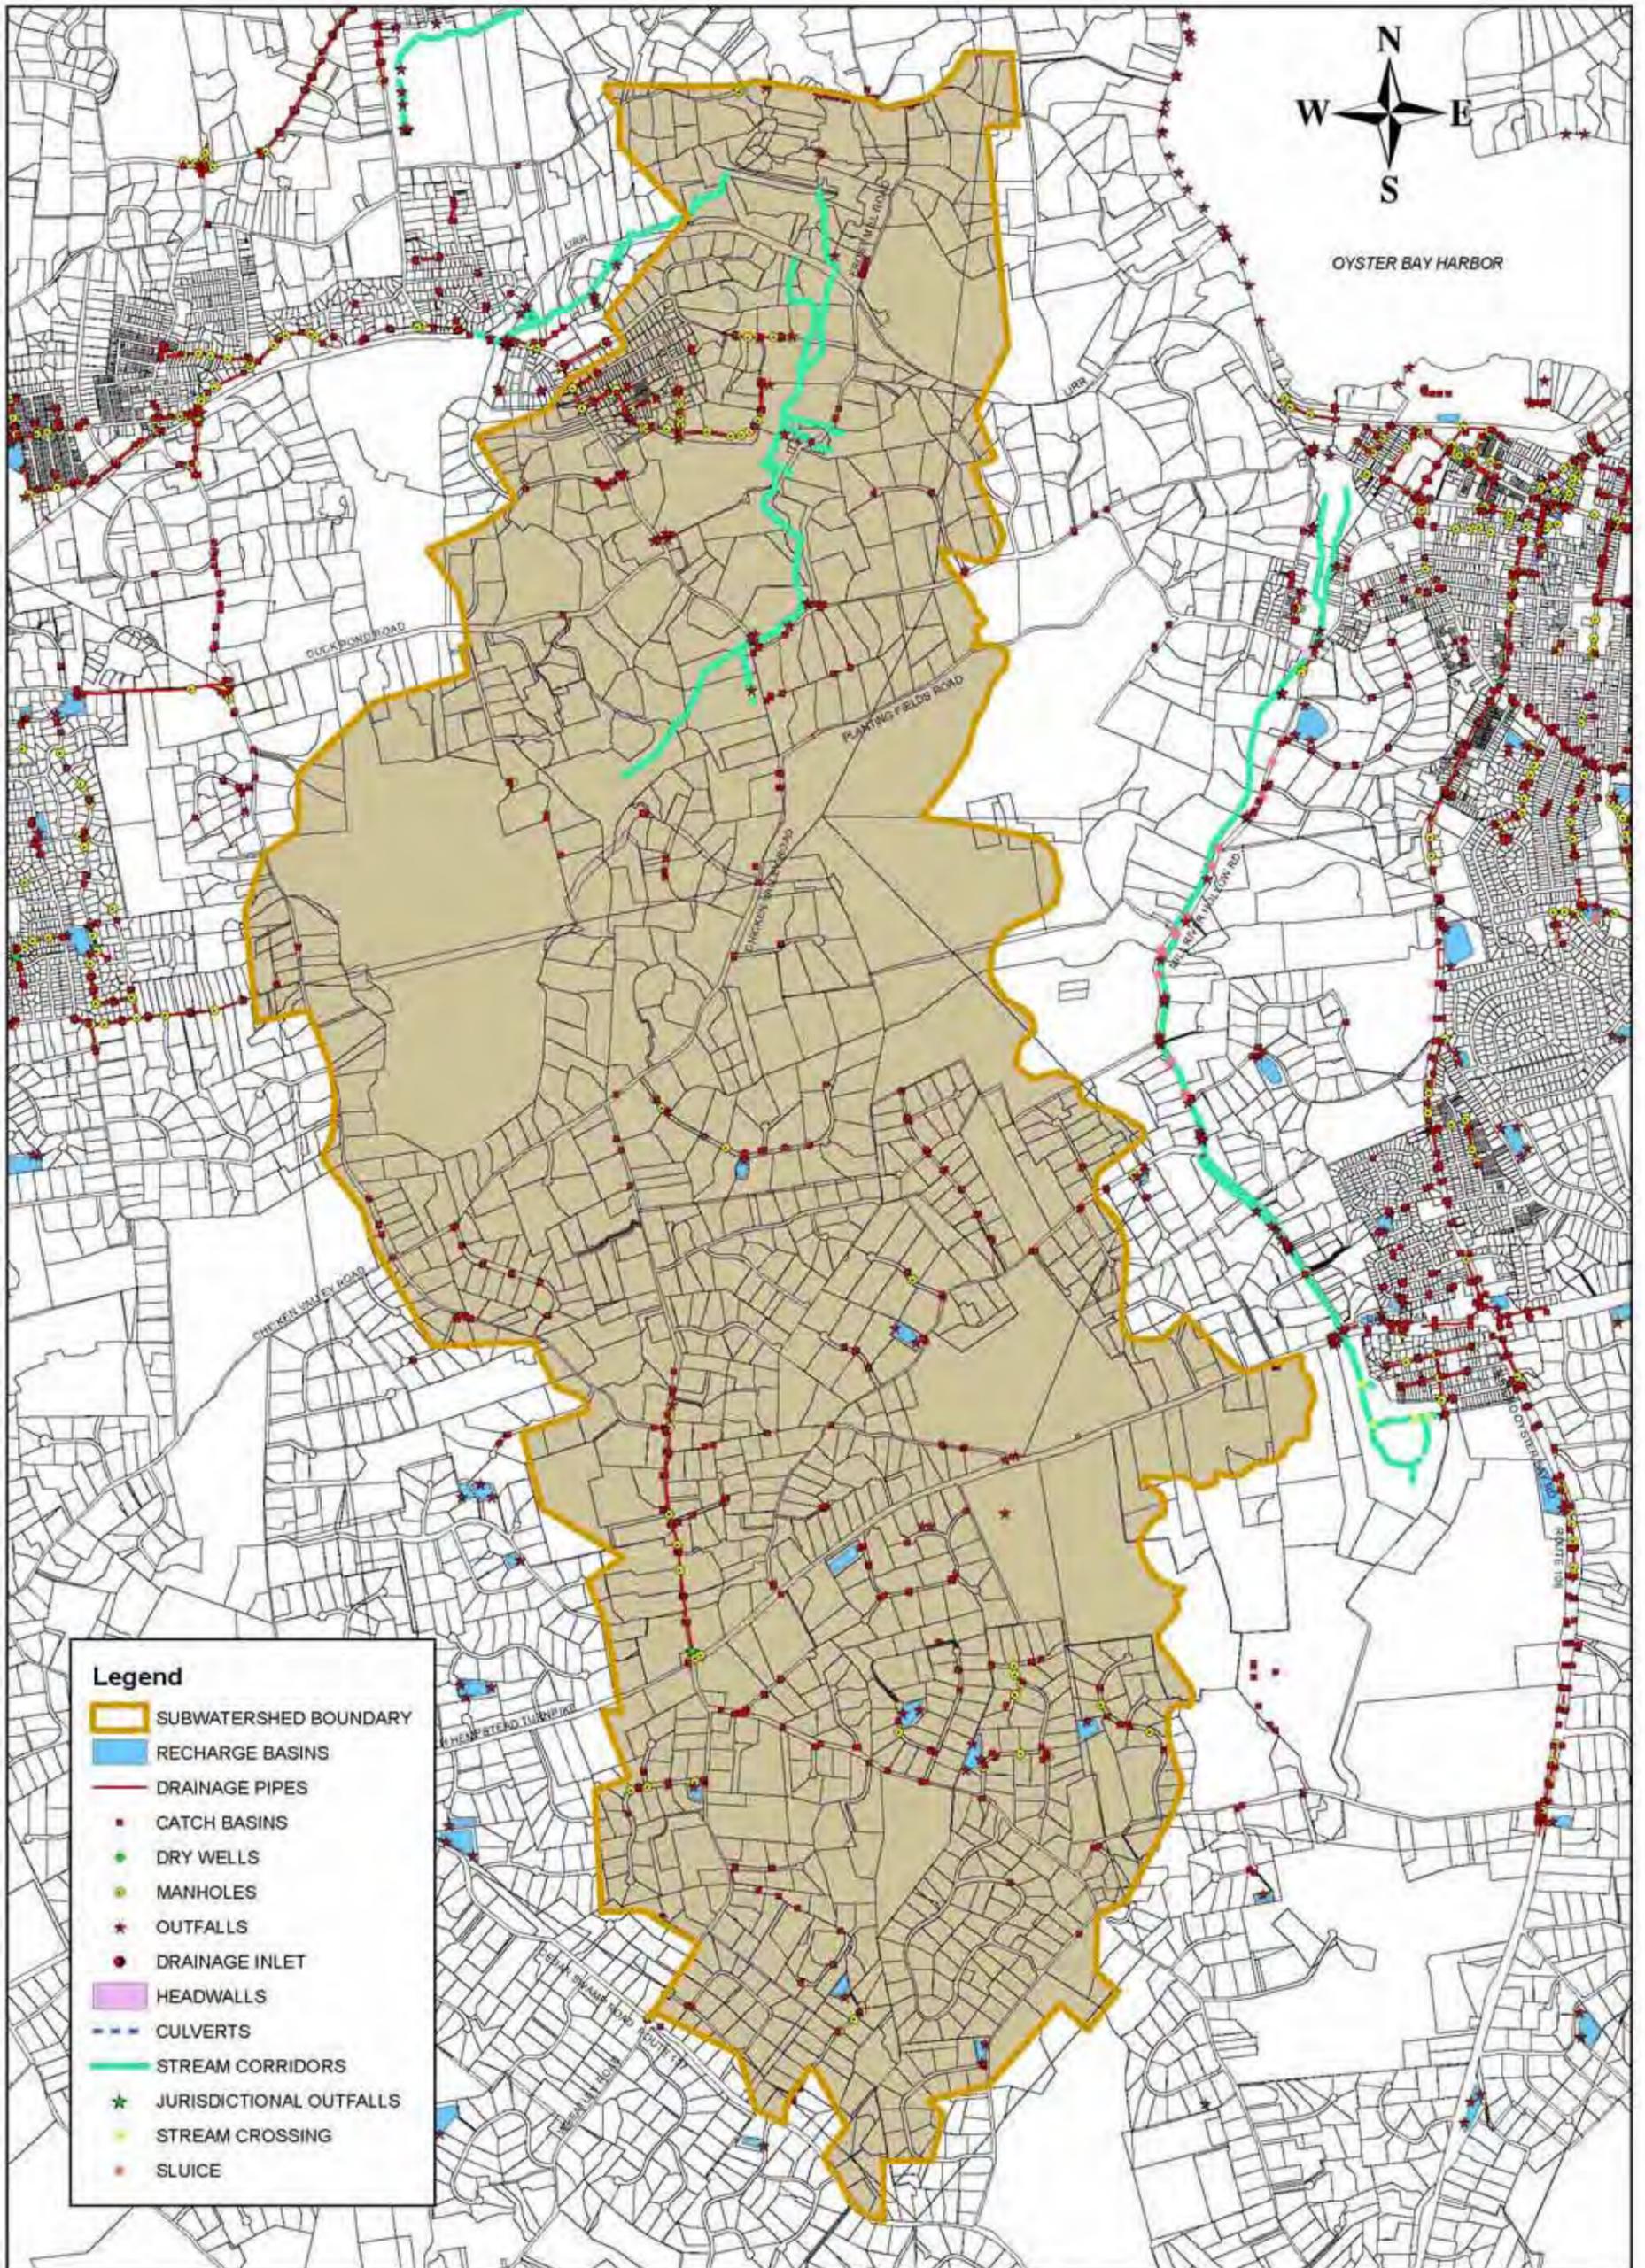
MAP 2-1
NASSAU COUNTY STORMWATER
MANAGEMENT PROGRAM
STORMWATER RUNOFF IMPACT ANALYSIS
DRAINAGE INFRASTRUCTURE
FRANCIS POND SUBWATERSHED

Using the mapping developed in Section 2.1.1, areas with incomplete drainage mapping were identified. A field survey of the drainage infrastructure in those locations was conducted. This task was performed in conjunction with the Stream Assessment described in Section 2.3. During the assessment, the stream corridor was walked to verify the mapped outfalls and to identify other locations where storm runoff appeared to be directly entering the stream. The drainage infrastructure upstream of each outfall was then field verified to identify the extent of the drainage infrastructure contributing to each outfall. The drainage infrastructure of the Francis Pond subwatershed is shown on Map 2-1.

The subwatershed has limited drainage infrastructure that outfall to the waterbodies. The systems identified include two piped drainage systems that outfall to the west side of Shu Swamp and numerous individual catch basins and leaching structures located along the subwatershed roads. Several of these small individual structures have outfalls to the waterbodies.

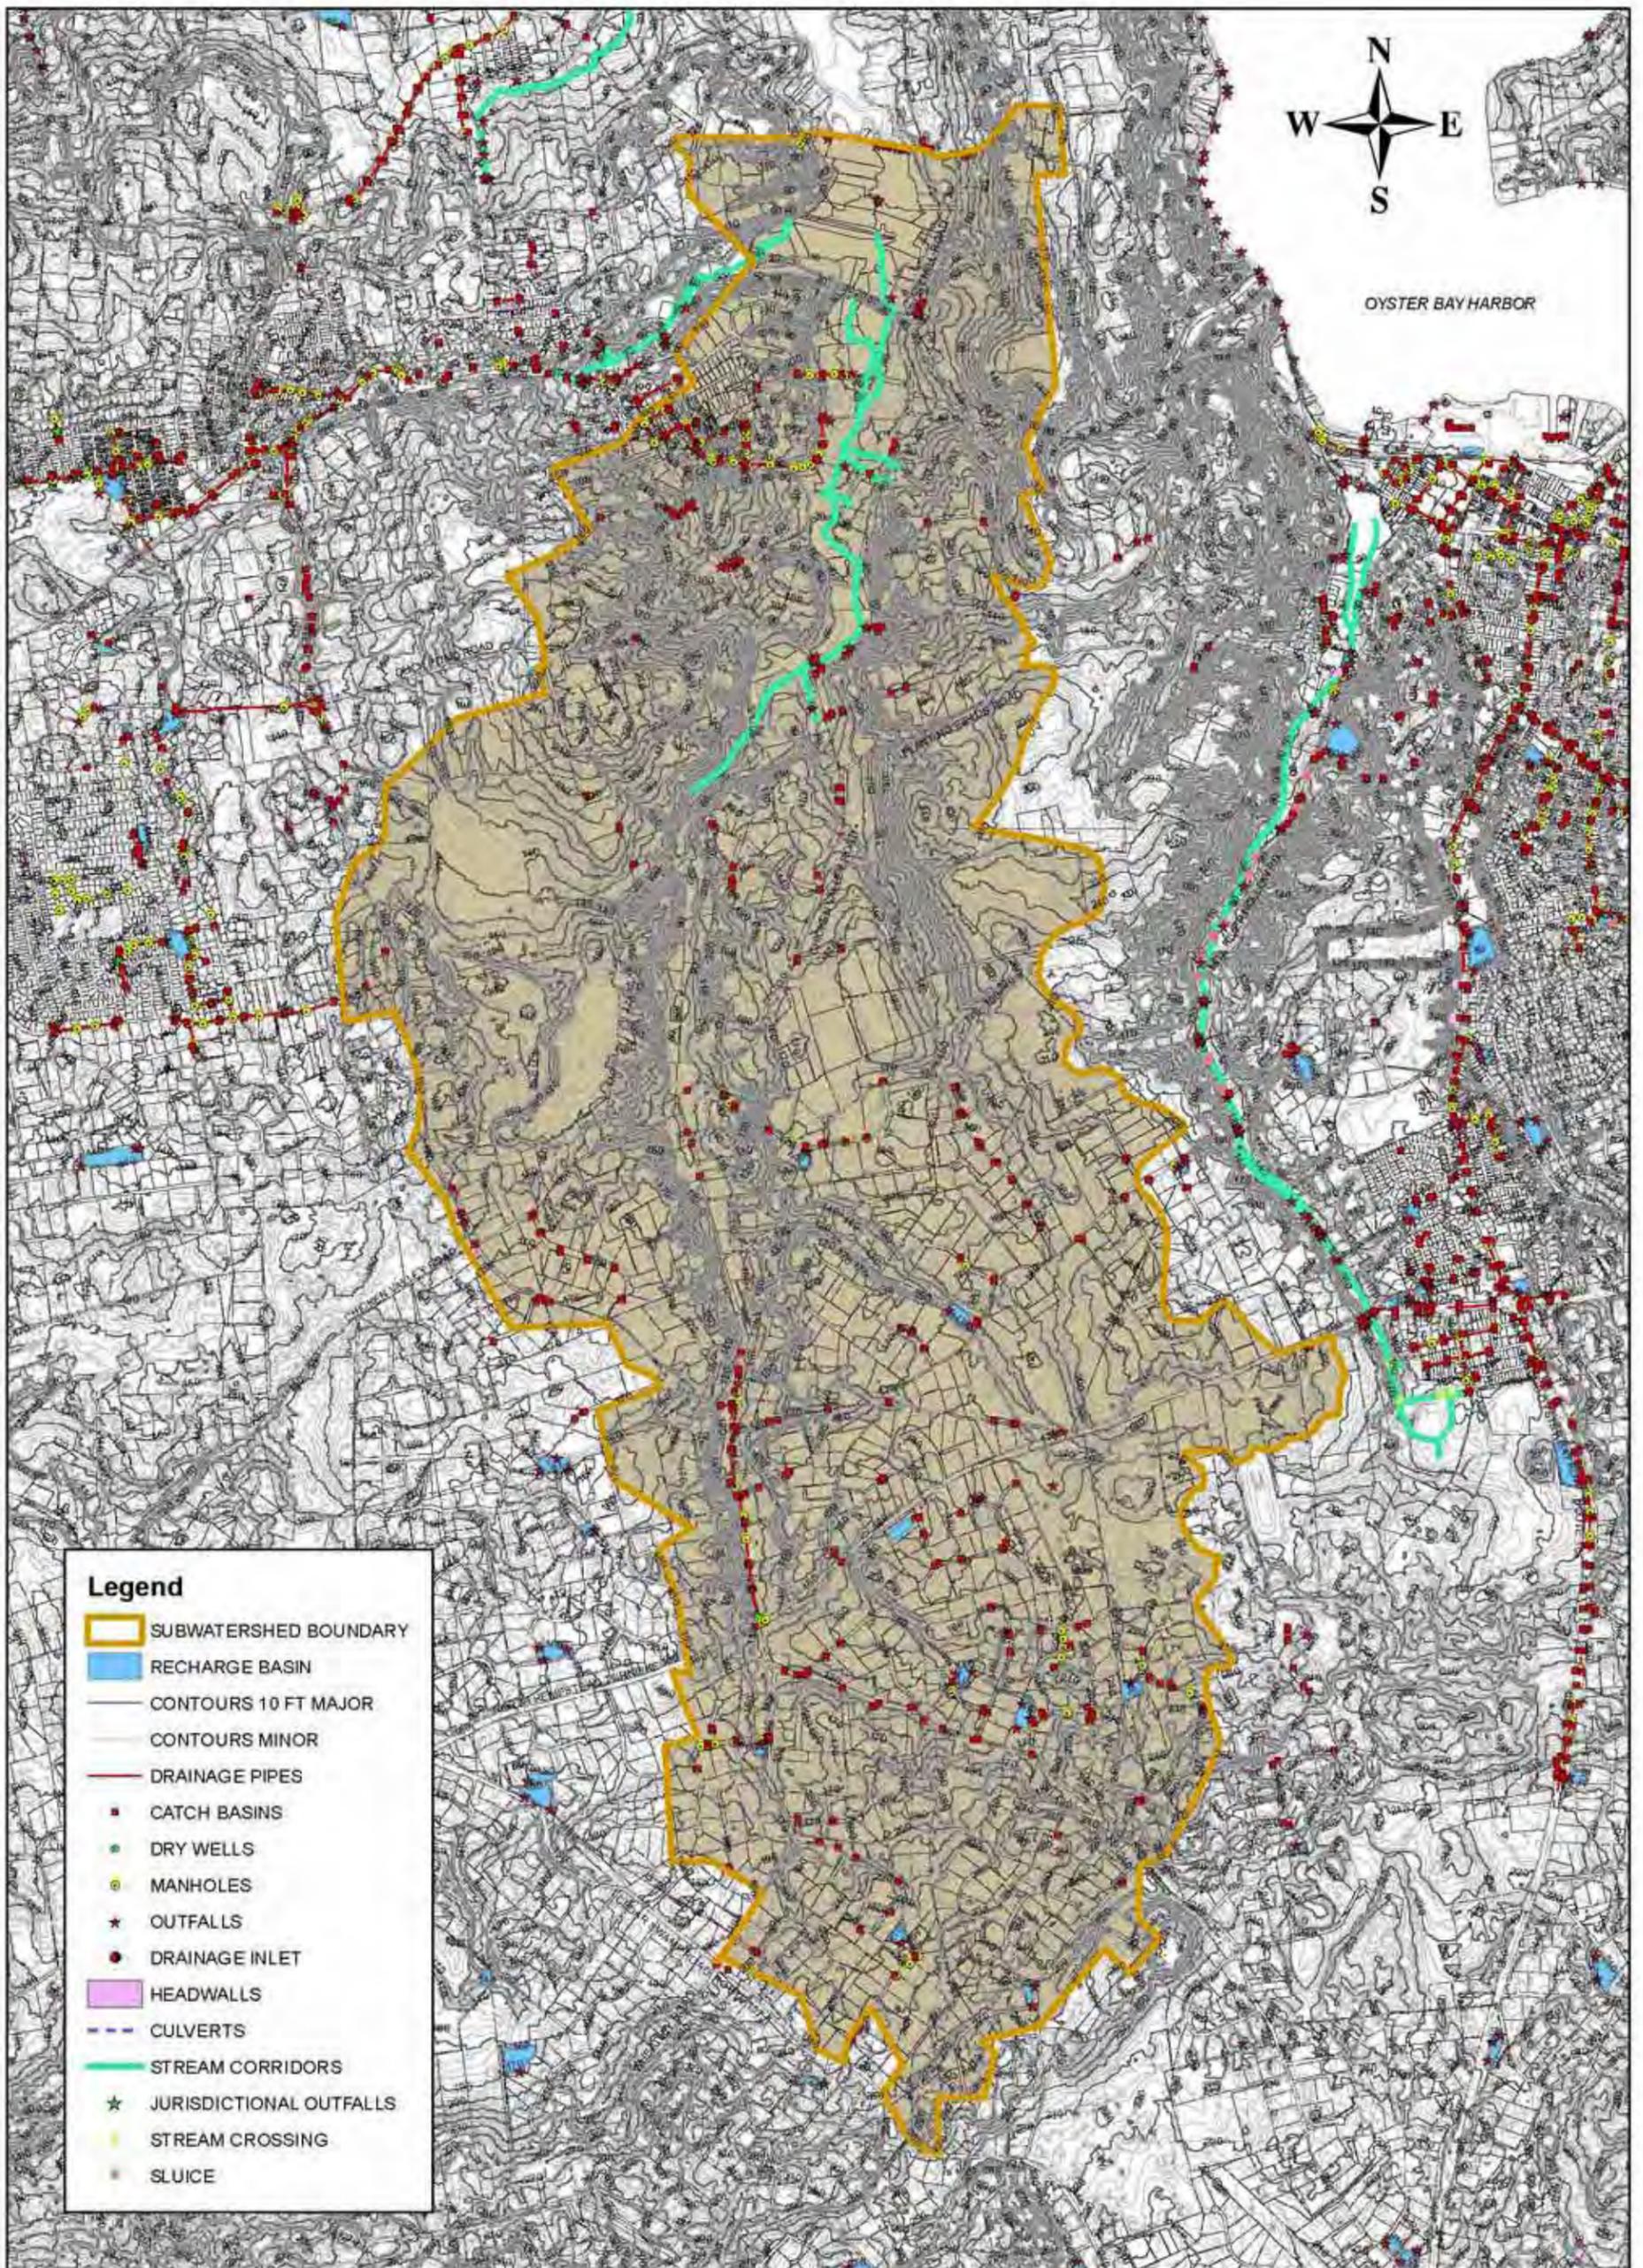
MAP 2-2
 NASSAU COUNTY STORMWATER
 MANAGEMENT PROGRAM
 STORMWATER RUNOFF IMPACT ANALYSIS
 CONTOURS
 FRANCIS POND SUBWATERSHED

The geographic limits of the Francis Pond subwatershed were defined through review of topographic maps, plans of existing municipal drainage infrastructure, and field assessment. Map 2-2 shows subwatershed boundary along with the subwatershed topography along with existing drainage infrastructure.

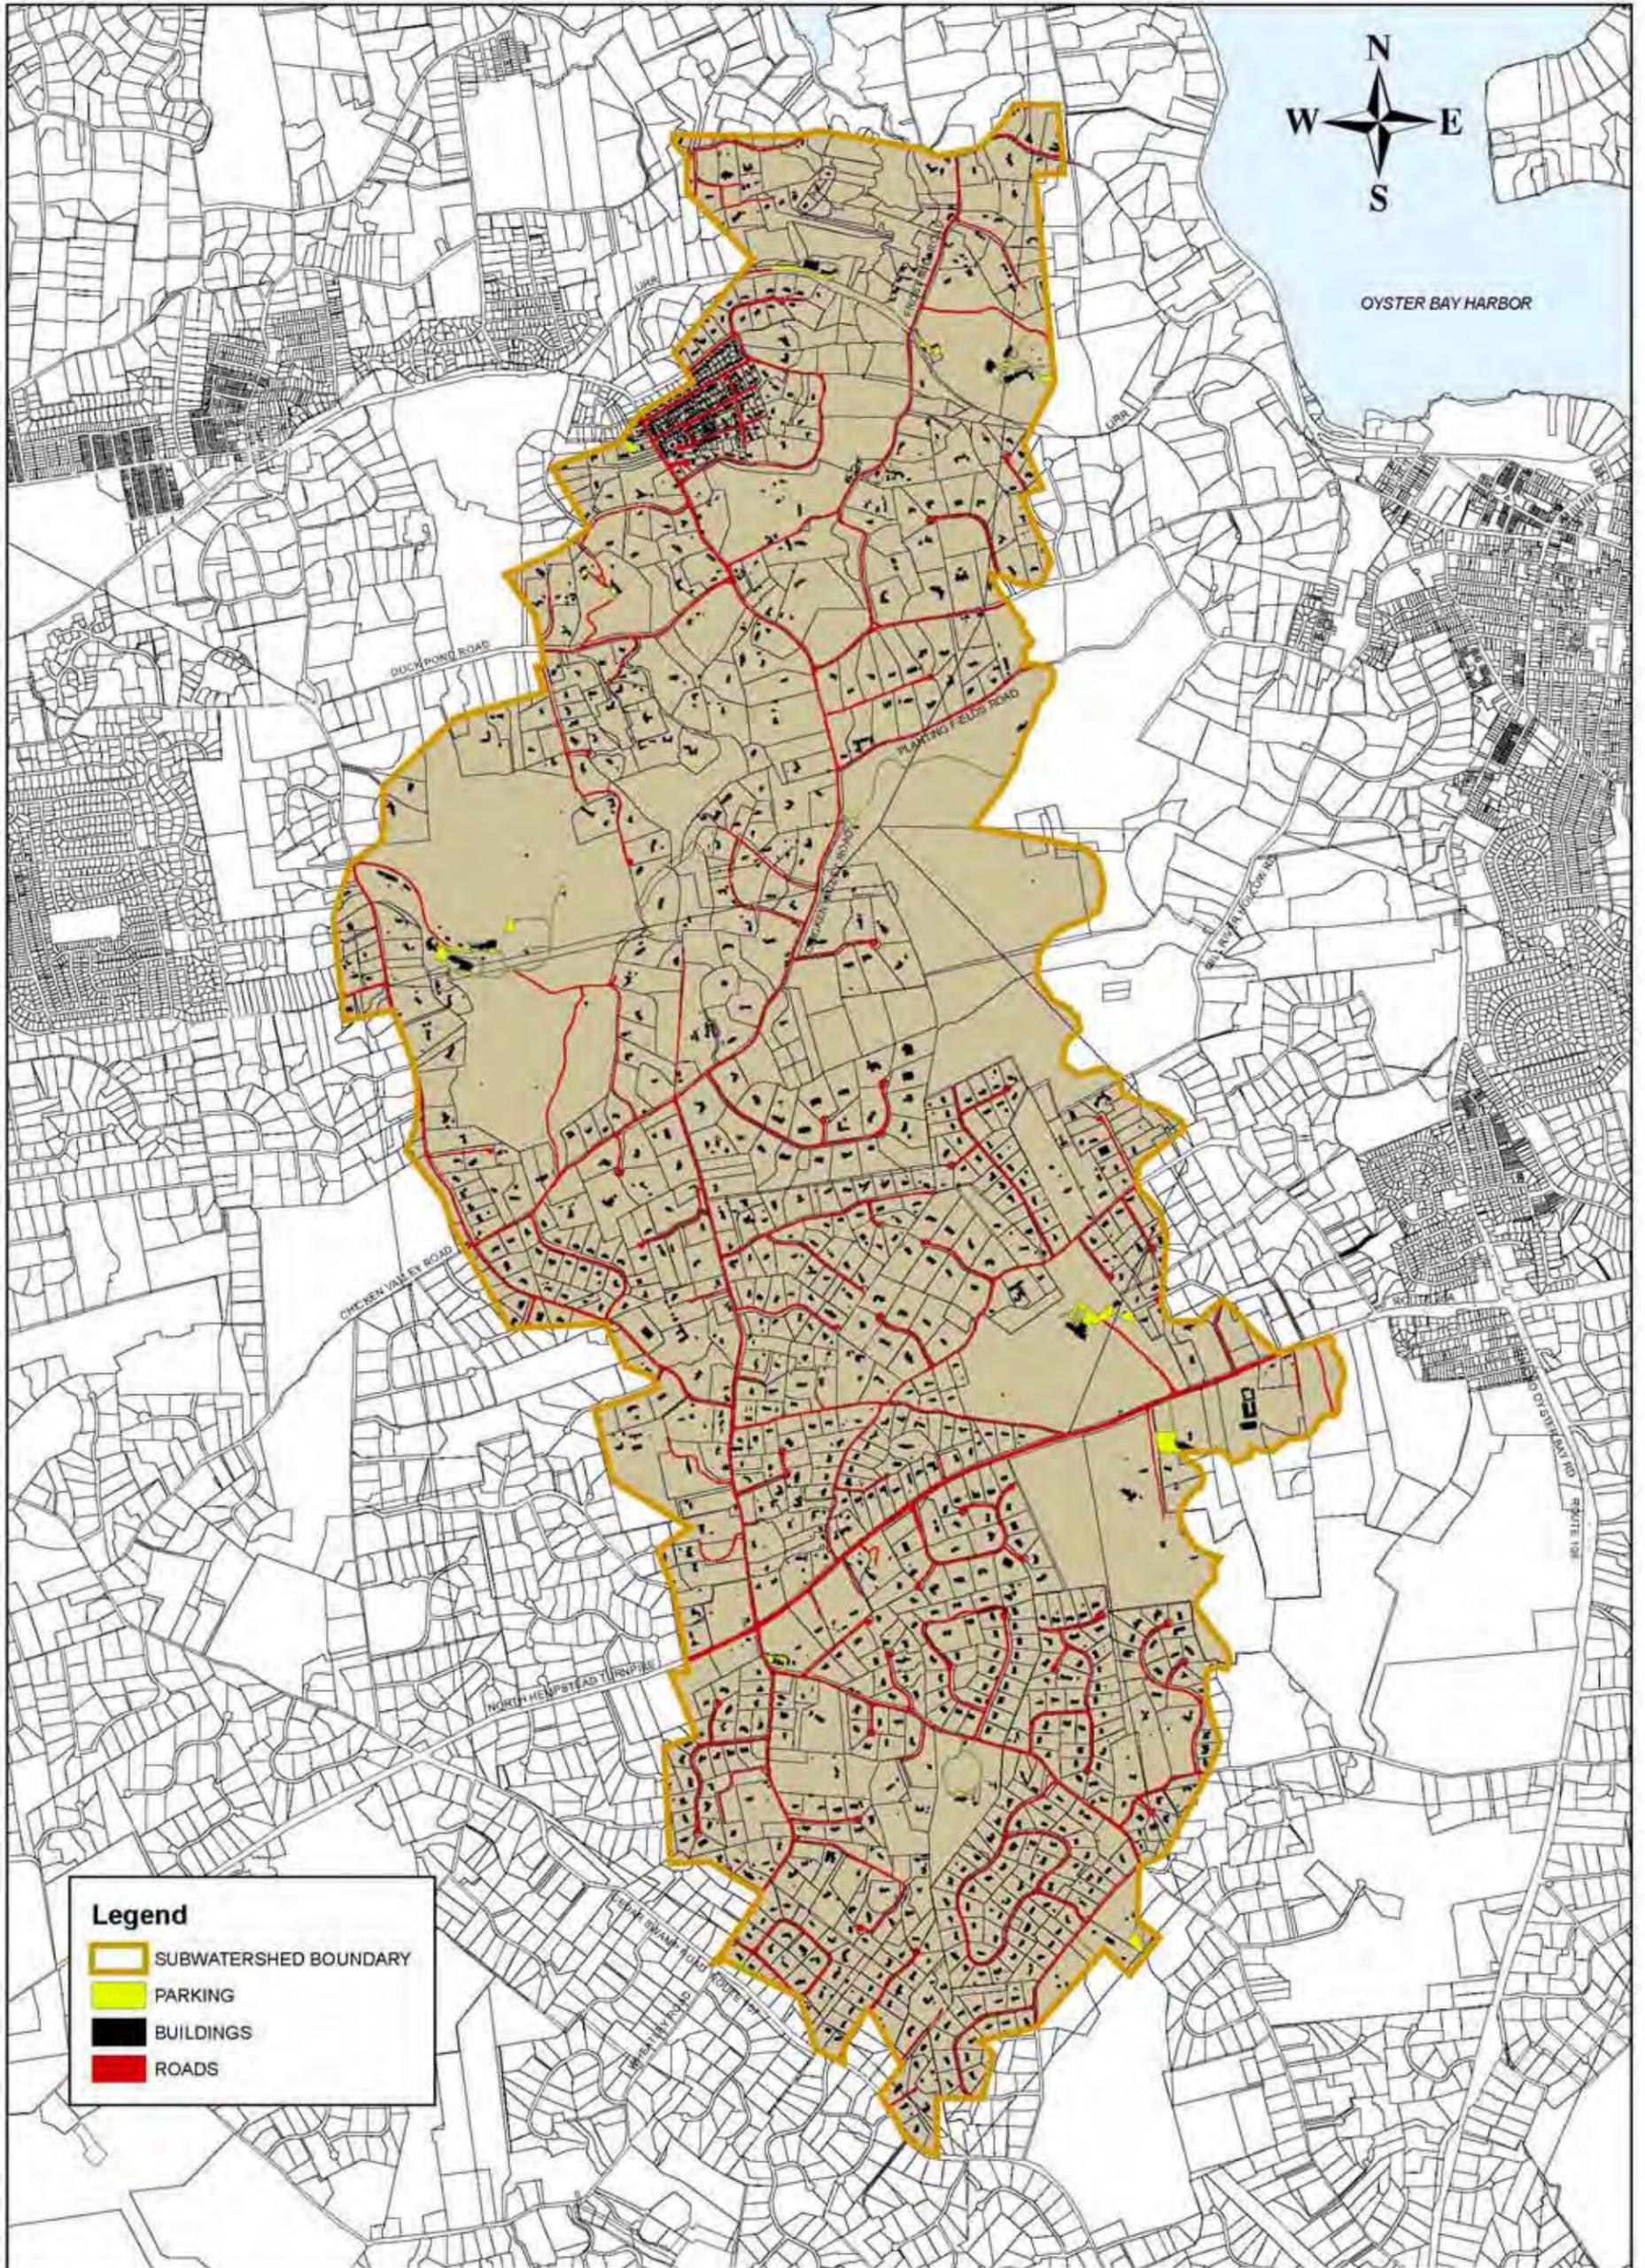
MAP 2-3
 NASSAU COUNTY STORMWATER
 MANAGEMENT PROGRAM
 STORMWATER RUNOFF IMPACT ANALYSIS
 IMPERVIOUS AREAS
 FRANCIS POND SUBWATERSHED

The impervious cover data was entered into the standard table from the Procedures Manual. The data table and results of calculations are shown on Table 2-3. The impervious area of the Francis Pond subwatershed is 261 acres of the 4,793 total subwatershed acres. This represents 5% of the subwatershed. Based on the 5% impervious figure, Francis Pond receives a subwatershed classification of sensitive stream.

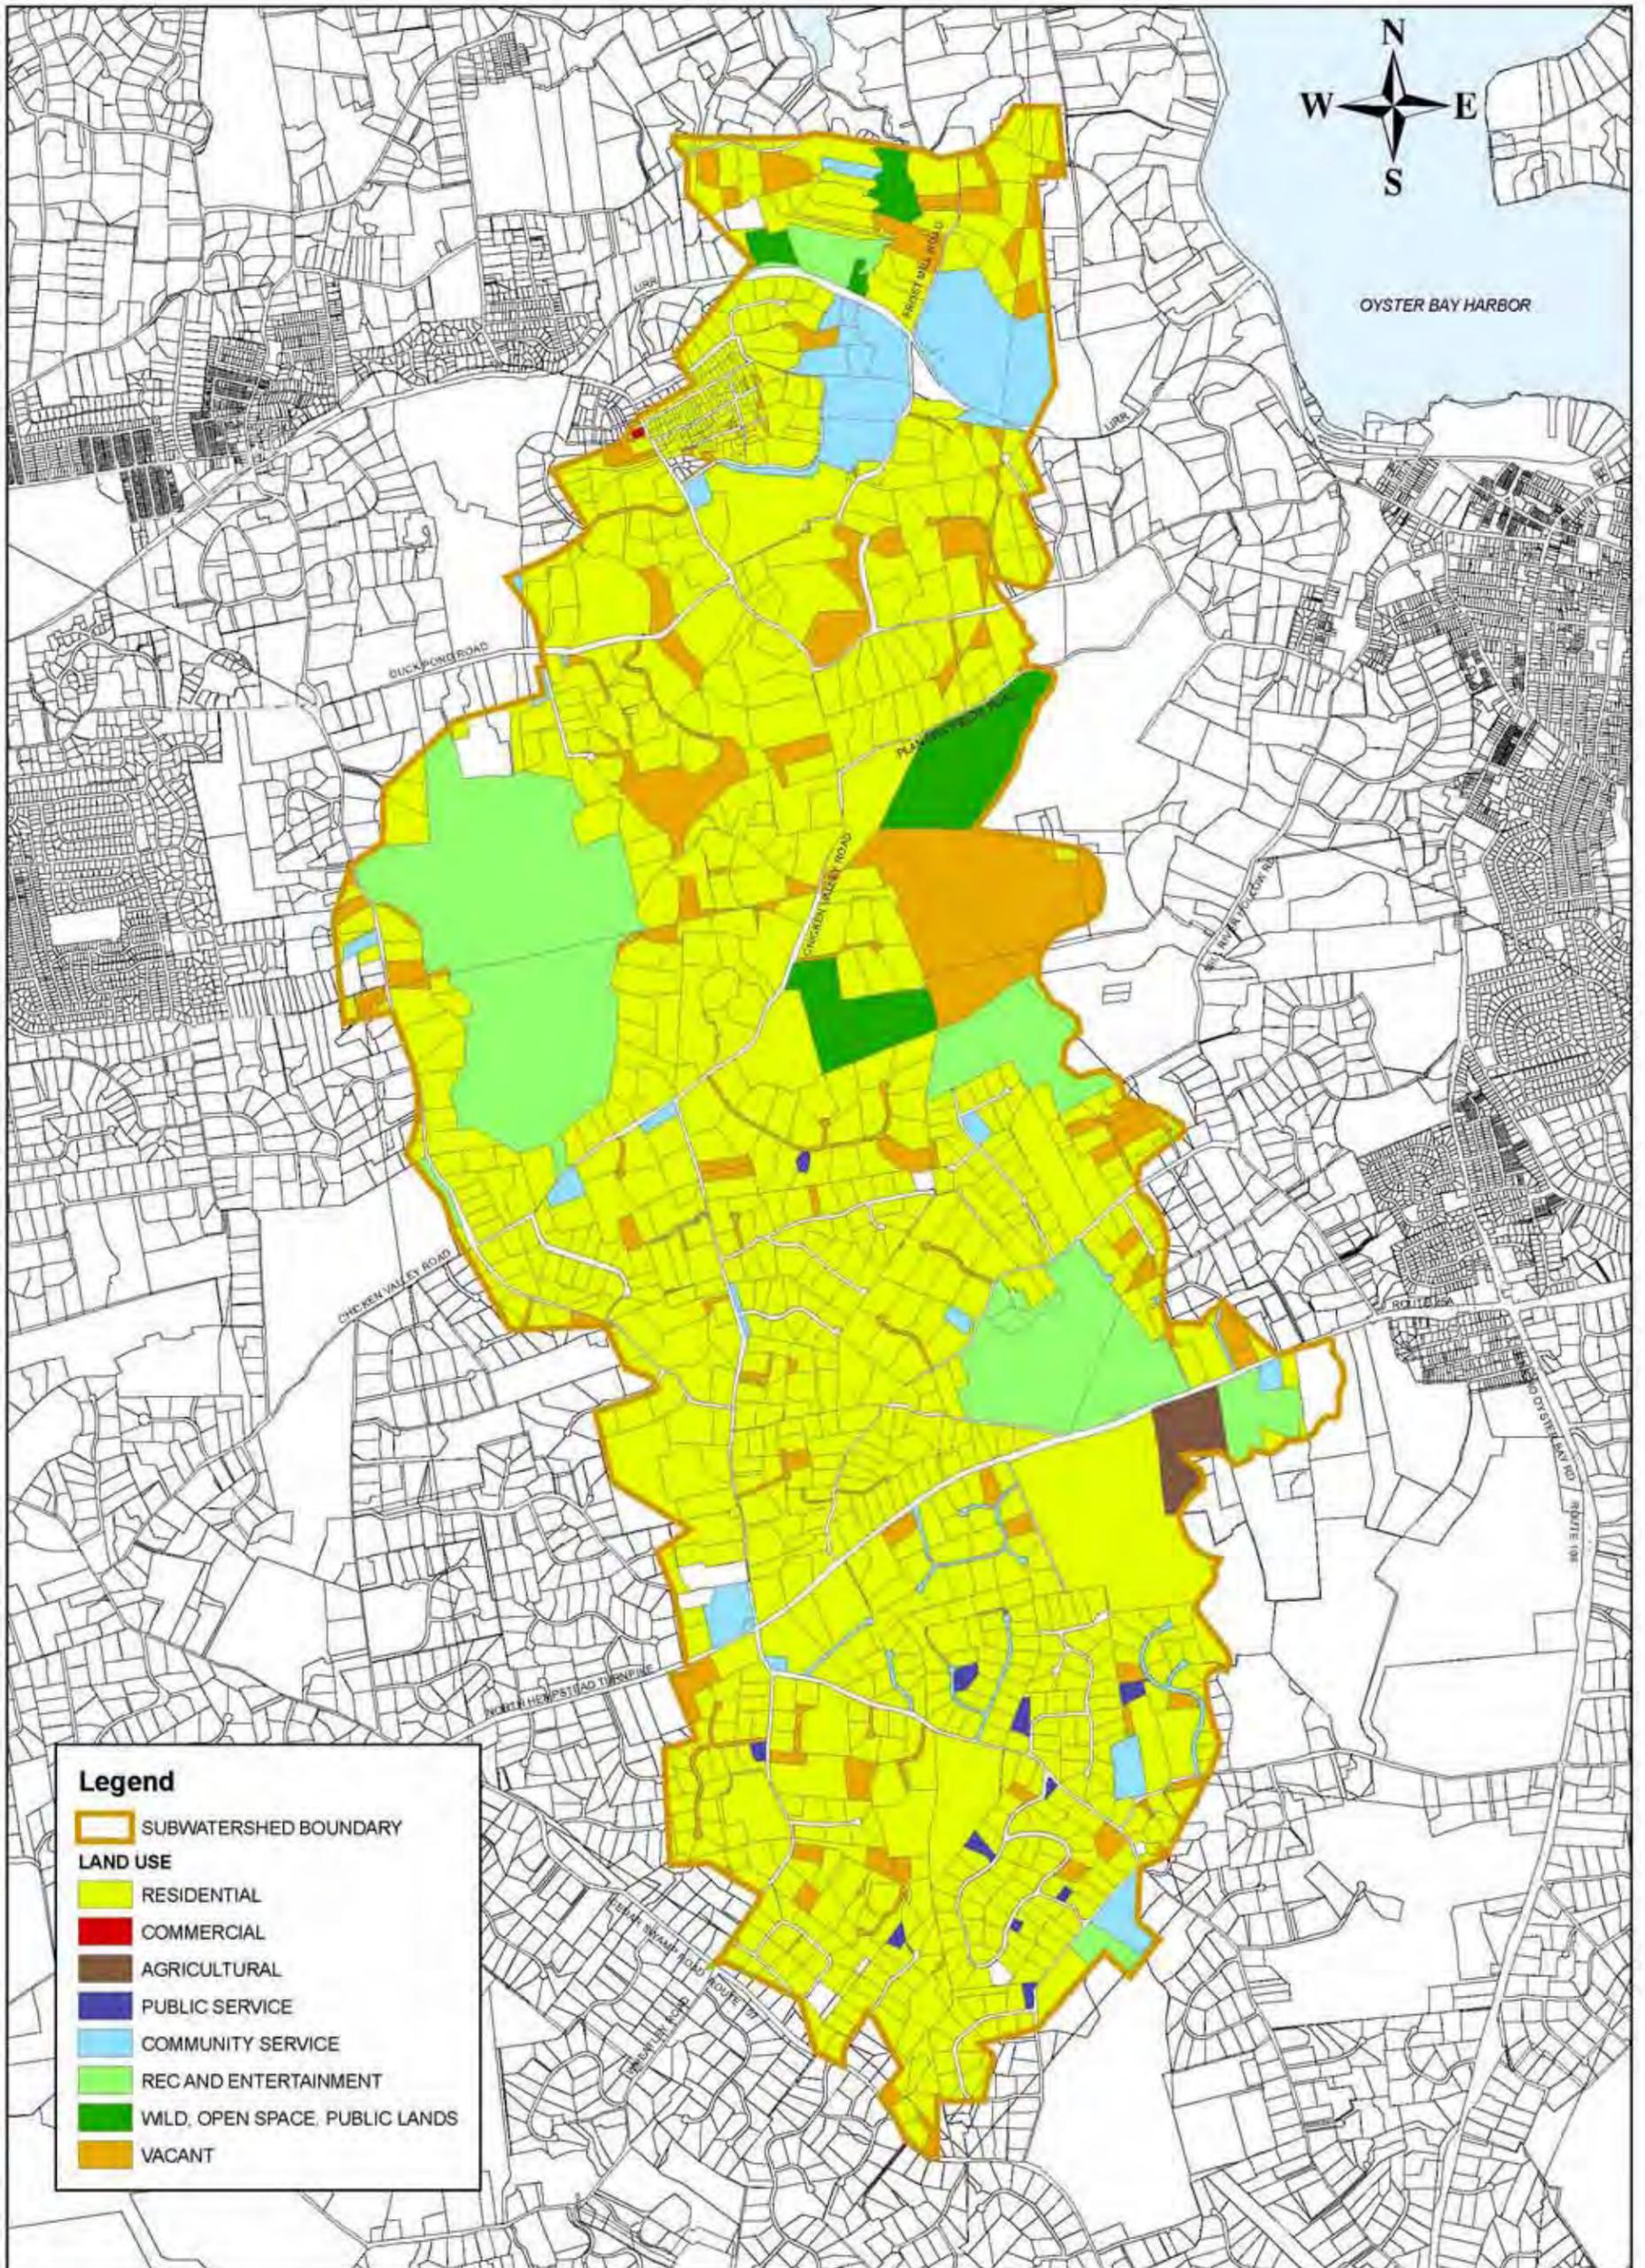
MAP 2-4
NASSAU COUNTY STORMWATER
MANAGEMENT PROGRAM
STORMWATER RUNOFF IMPACT ANALYSIS
LANDUSE
FRANCIS POND SUBWATERSHED

The Francis Pond subwatershed is approximately 2 miles long, beginning at Route 107 (Cedar Swamp Road) and ending at Mill Neck Creek, just north of Feeks Lane. The Francis Pond subwatershed encompasses approximately 4,793 acres that potentially contribute runoff that could eventually enter the waterbody. The watershed is approximately 8,000' wide. Some northern sections of the subwatershed appear to be self-contained and no longer contribute runoff to the waterbody. See Section 3 for a description of the areas assessed to be self-contained. The subwatershed is 67%

residential land use and 31% “other”. The “other” category includes parks and community services. There is no commercial or industrial land use in the watershed. Of the 1,093 residences in the subwatershed, 864 or 79% are larger than one acre in size.

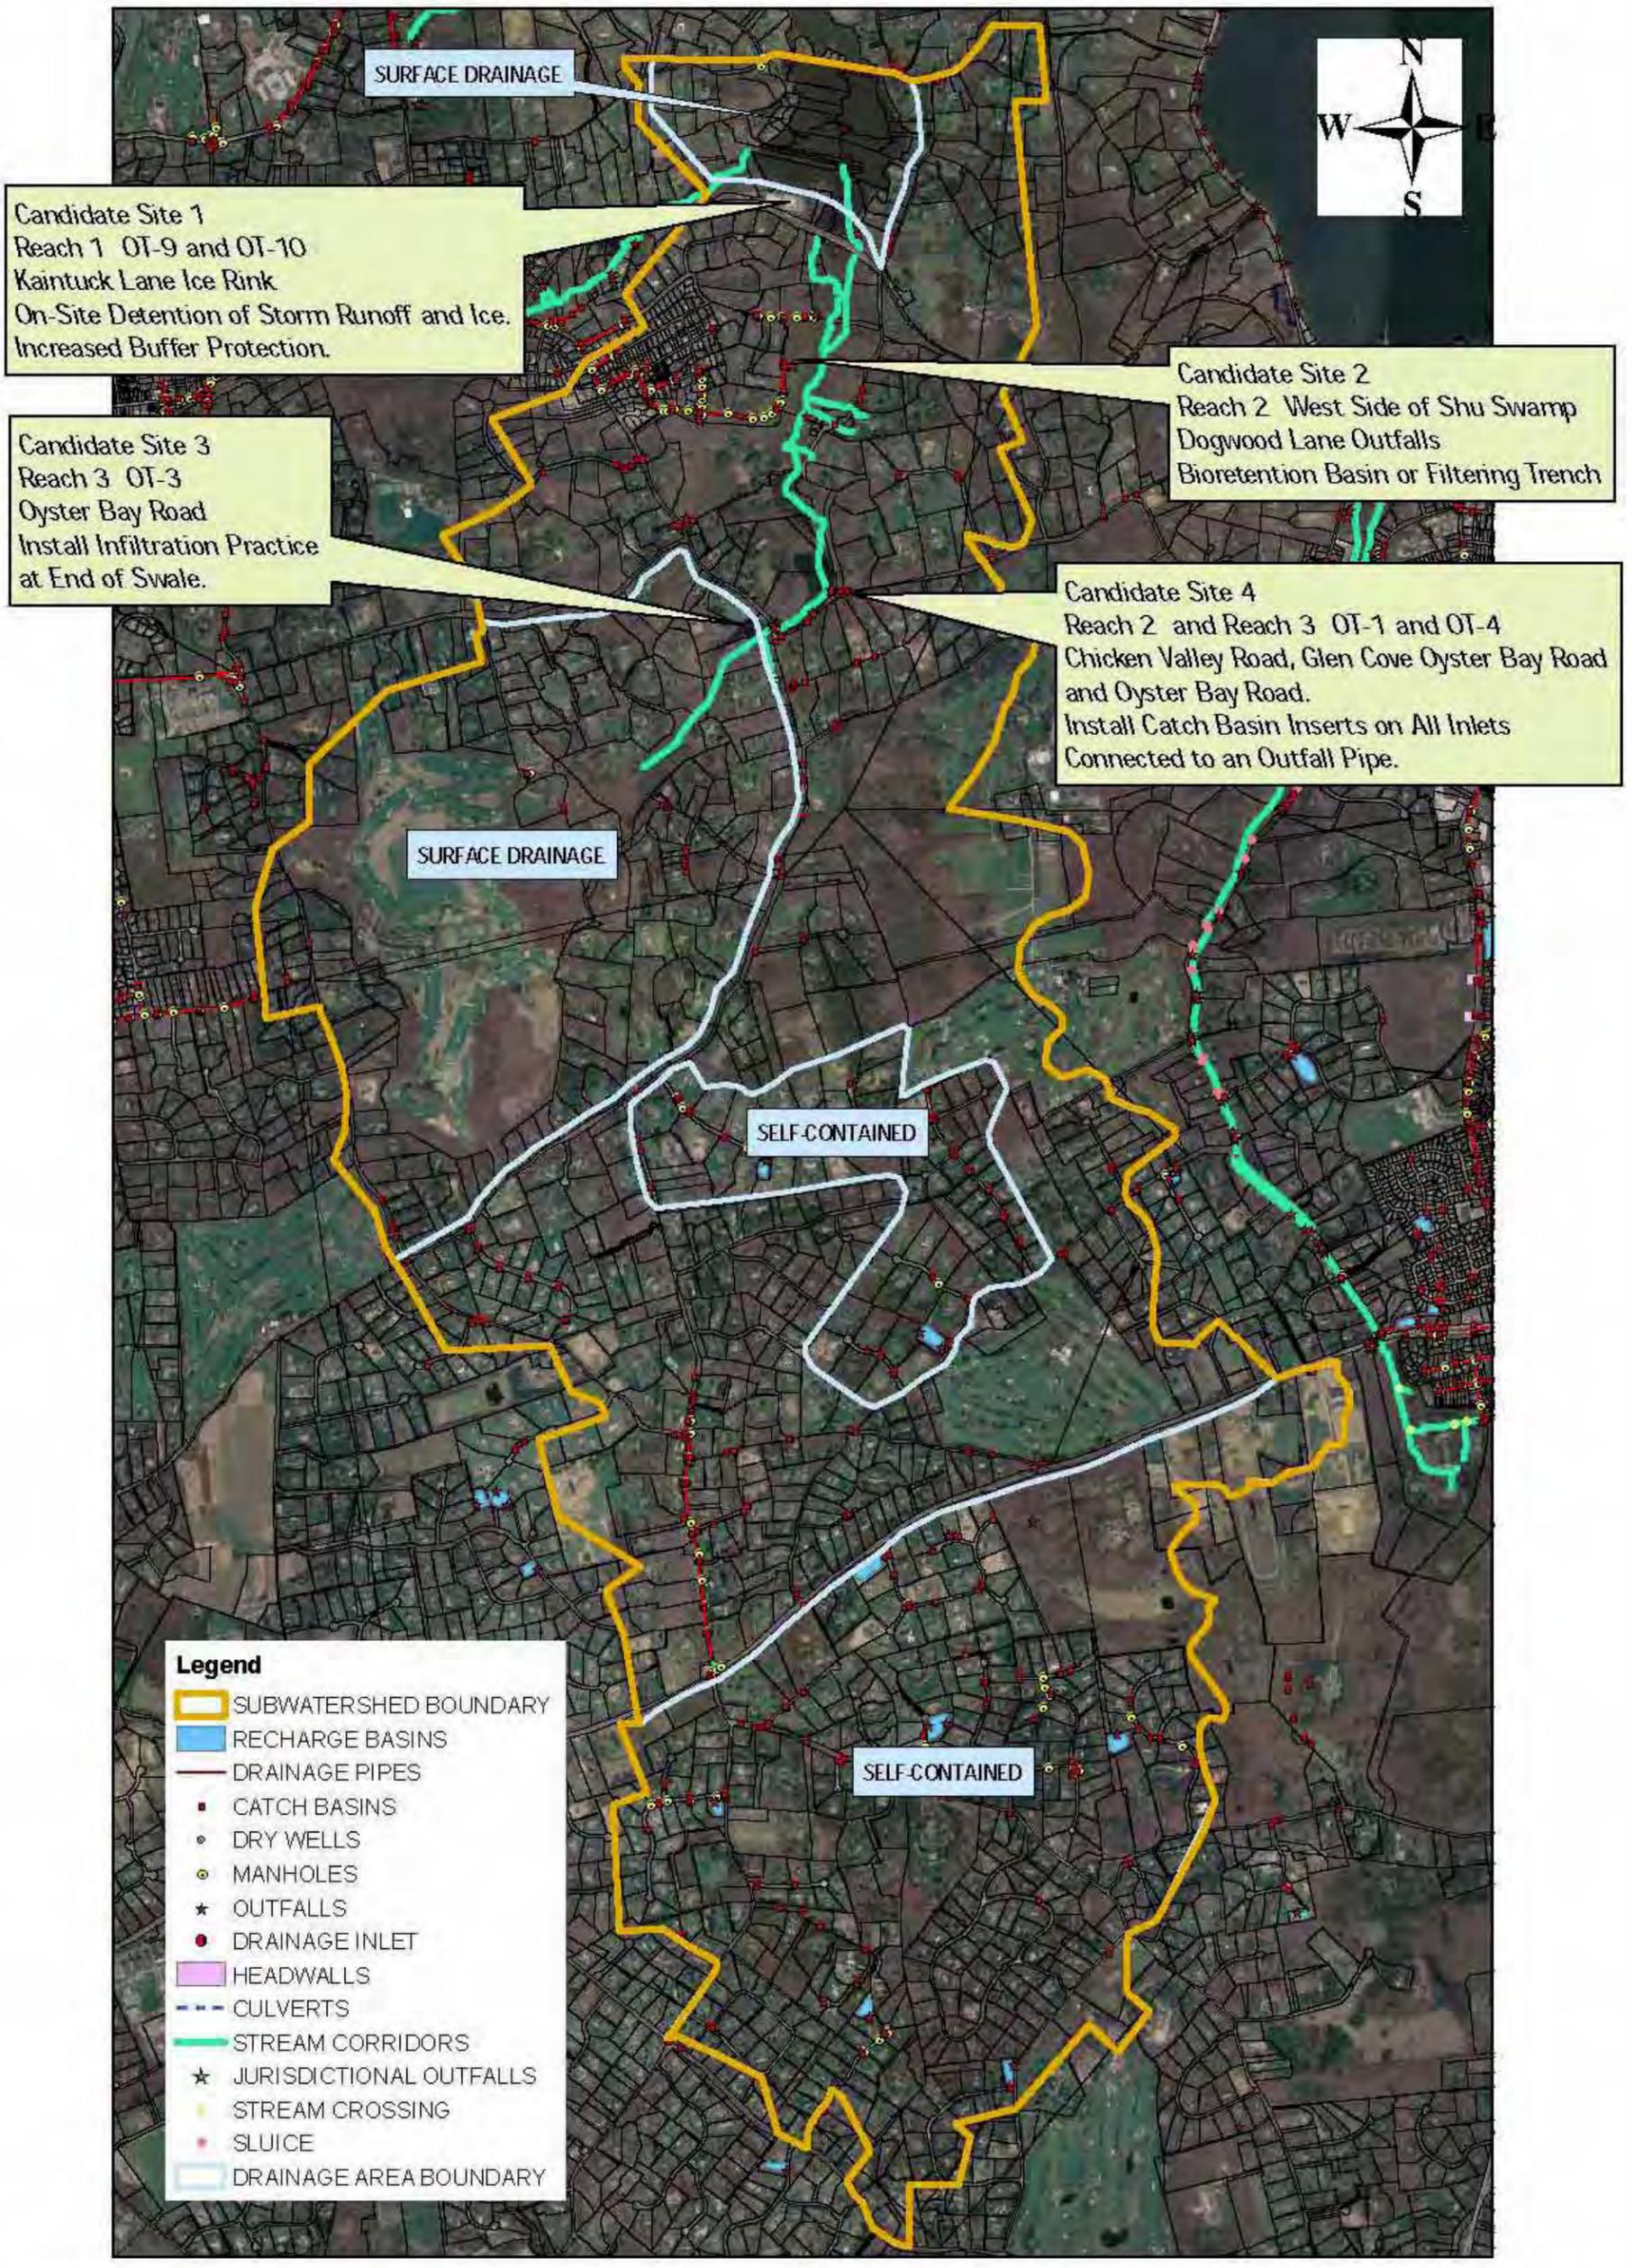
MAP 3-1
NASSAU COUNTY STORMWATER
MANAGEMENT PROGRAM
STORMWATER RUNOFF IMPACT ANALYSIS
SMP CANDIDATE SITE MAP
FRANCIS POND SUBWATERSHED

Francis Pond Subwatershed has several potential parcels that could be used to site SMP's from several of the outfalls identified. The proposed candidate sites and the SMPs discussed herein are shown on Map 3-1 Candidate Sites Map.

Candidate Site 1 is at outfalls OT-1 and OT-2 in Reach 1 at the ice skating facility at the eastern end of Kaintuck Lane. The outfalls appear to discharge storm runoff from the building and roads. In addition, piles of melting ice and construction debris were located in close proximity to the pond. SMPs should be used to retain the site runoff on site and buffers should be increased to prevent stockpiling of materials along the shoreline.

Candidate Site 2 are the outfall located on the west side of Shu Swamp that were not located during the field assessment. It appears that these pipe outfall from the most extensive drainage systems in the subwatershed discharge into the Shu Swamp wetlands. The installation of filtering system such as bioretention basin upland of the wetland would reduce pollutant loads.

Candidate Site 3 is Reach 3 OT-3. The concrete swale contributes runoff to Upper Francis Pond. The installation of a SMP filtering technique such as a bioretention basin could remove pollutant from runoff at this location.

Candidate Site 4 are the areas in Reach 3 where several catch basin systems located on Chicken Valley Road, Glen Cove Oyster Bay Road and Oyster Bay Road have outfalls to Upper Francis Pond, including OT-1 and OT-4 and two Reach 2 outfalls that were not

field located. Installation of catch basin inserts would remove pollutants from the runoff in a concentrated area.
